Case Vehicle (A): 2002 Chevrolet	Vehicle (B): 2002 Dodge
Type: Trailblazer LT, 4-door SUV 4wd	Type: Durango, 4-door SUV 4wd
Driver: 54-year-old male	Driver: 47-year-old male
CDC: 12-FLEW-3, 00-RDAO-3	CDC: 12-FDEW-4

This is a fatal crash; the driver of case vehicle (A) was fatally injured in this severe offset-frontal crash.

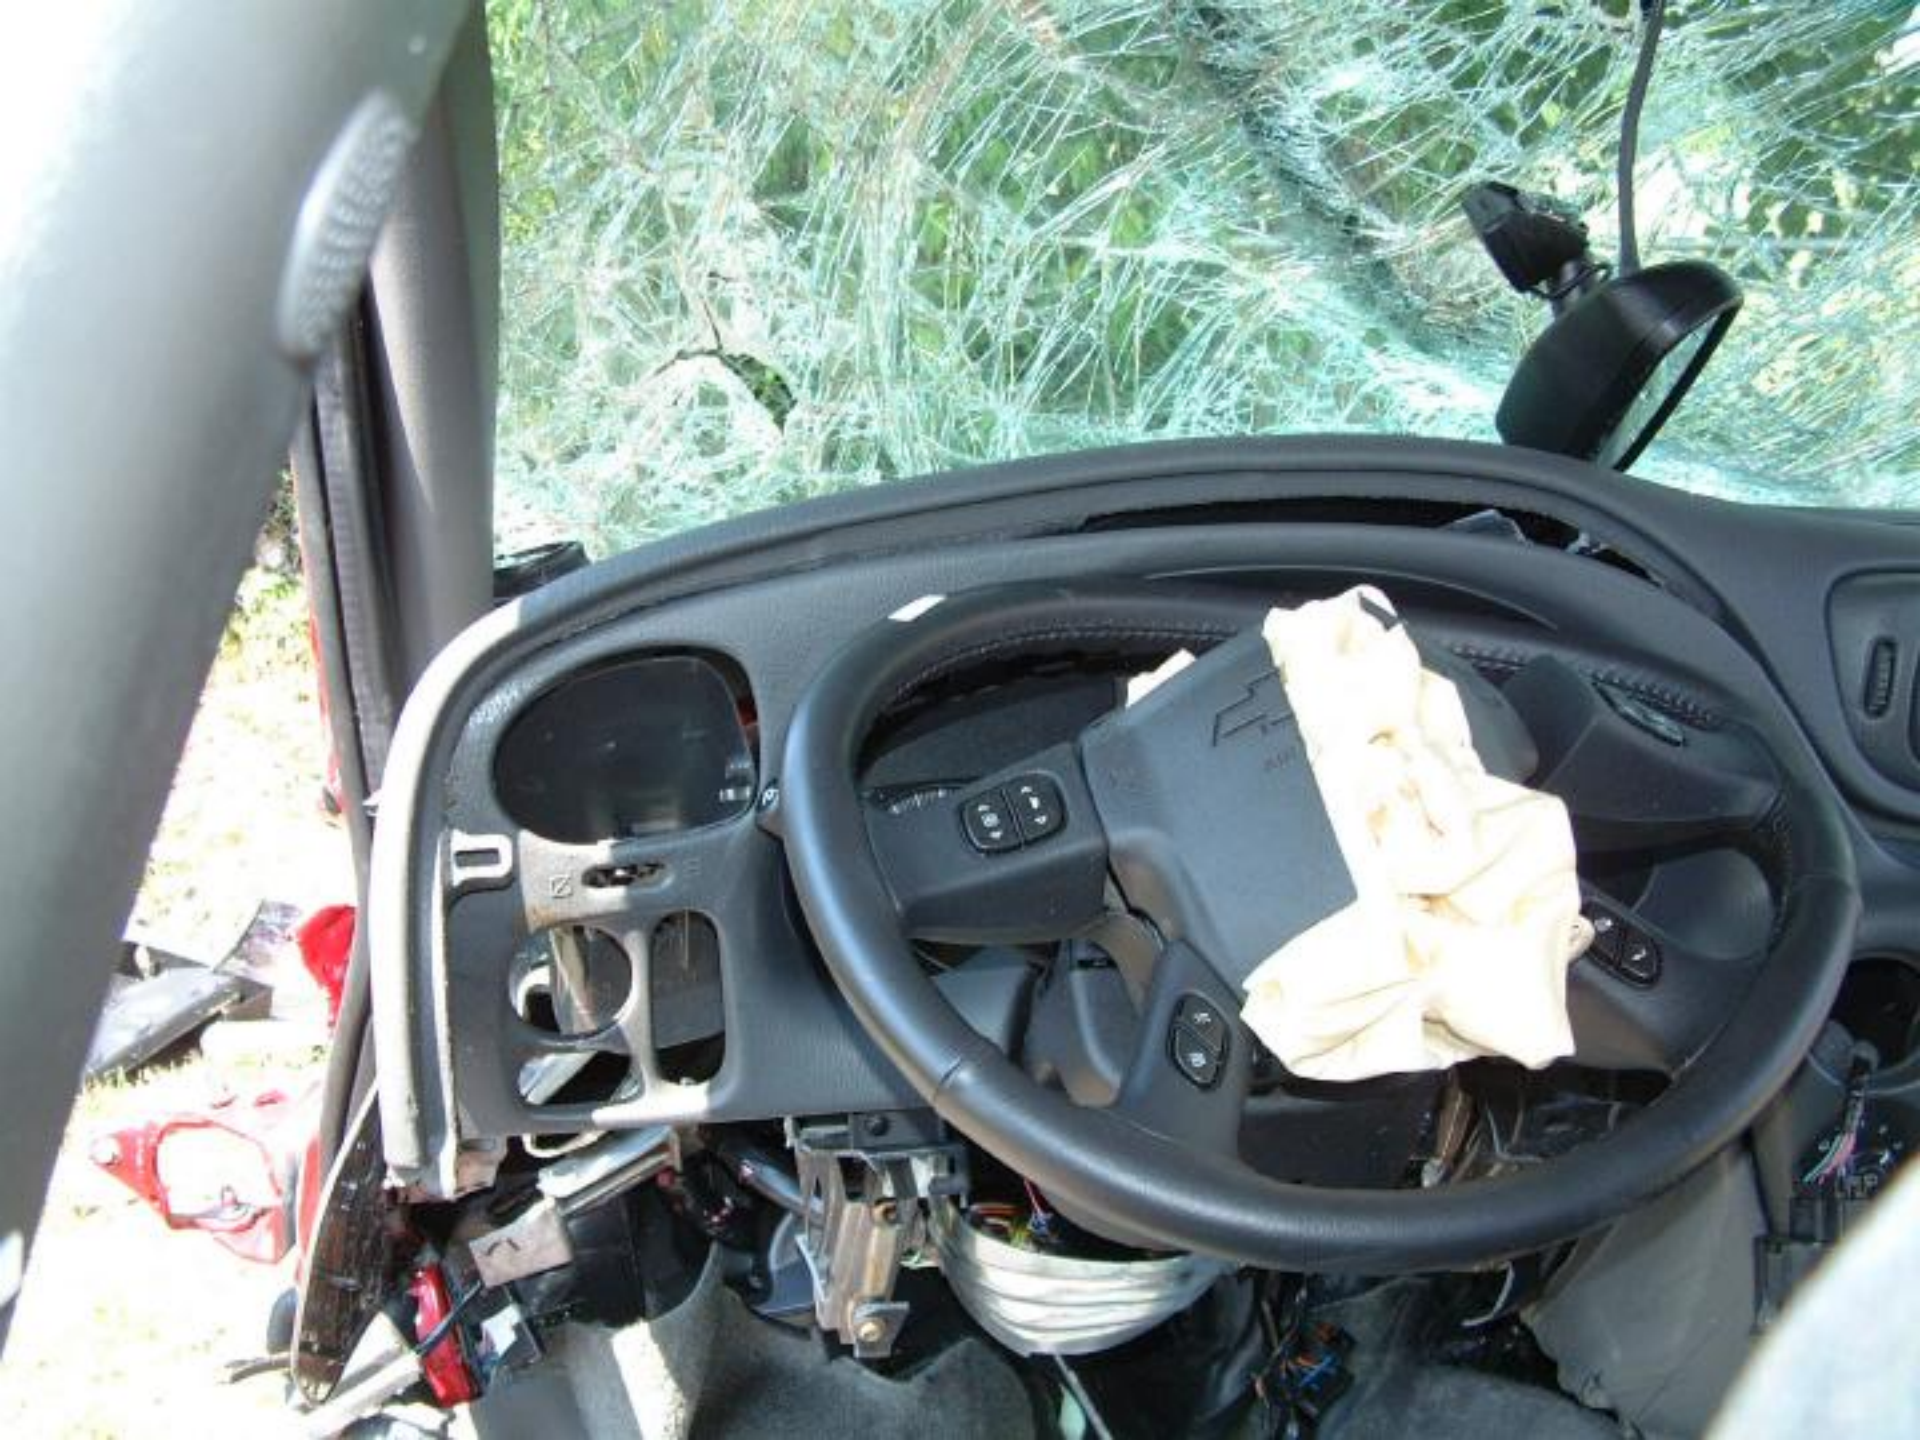
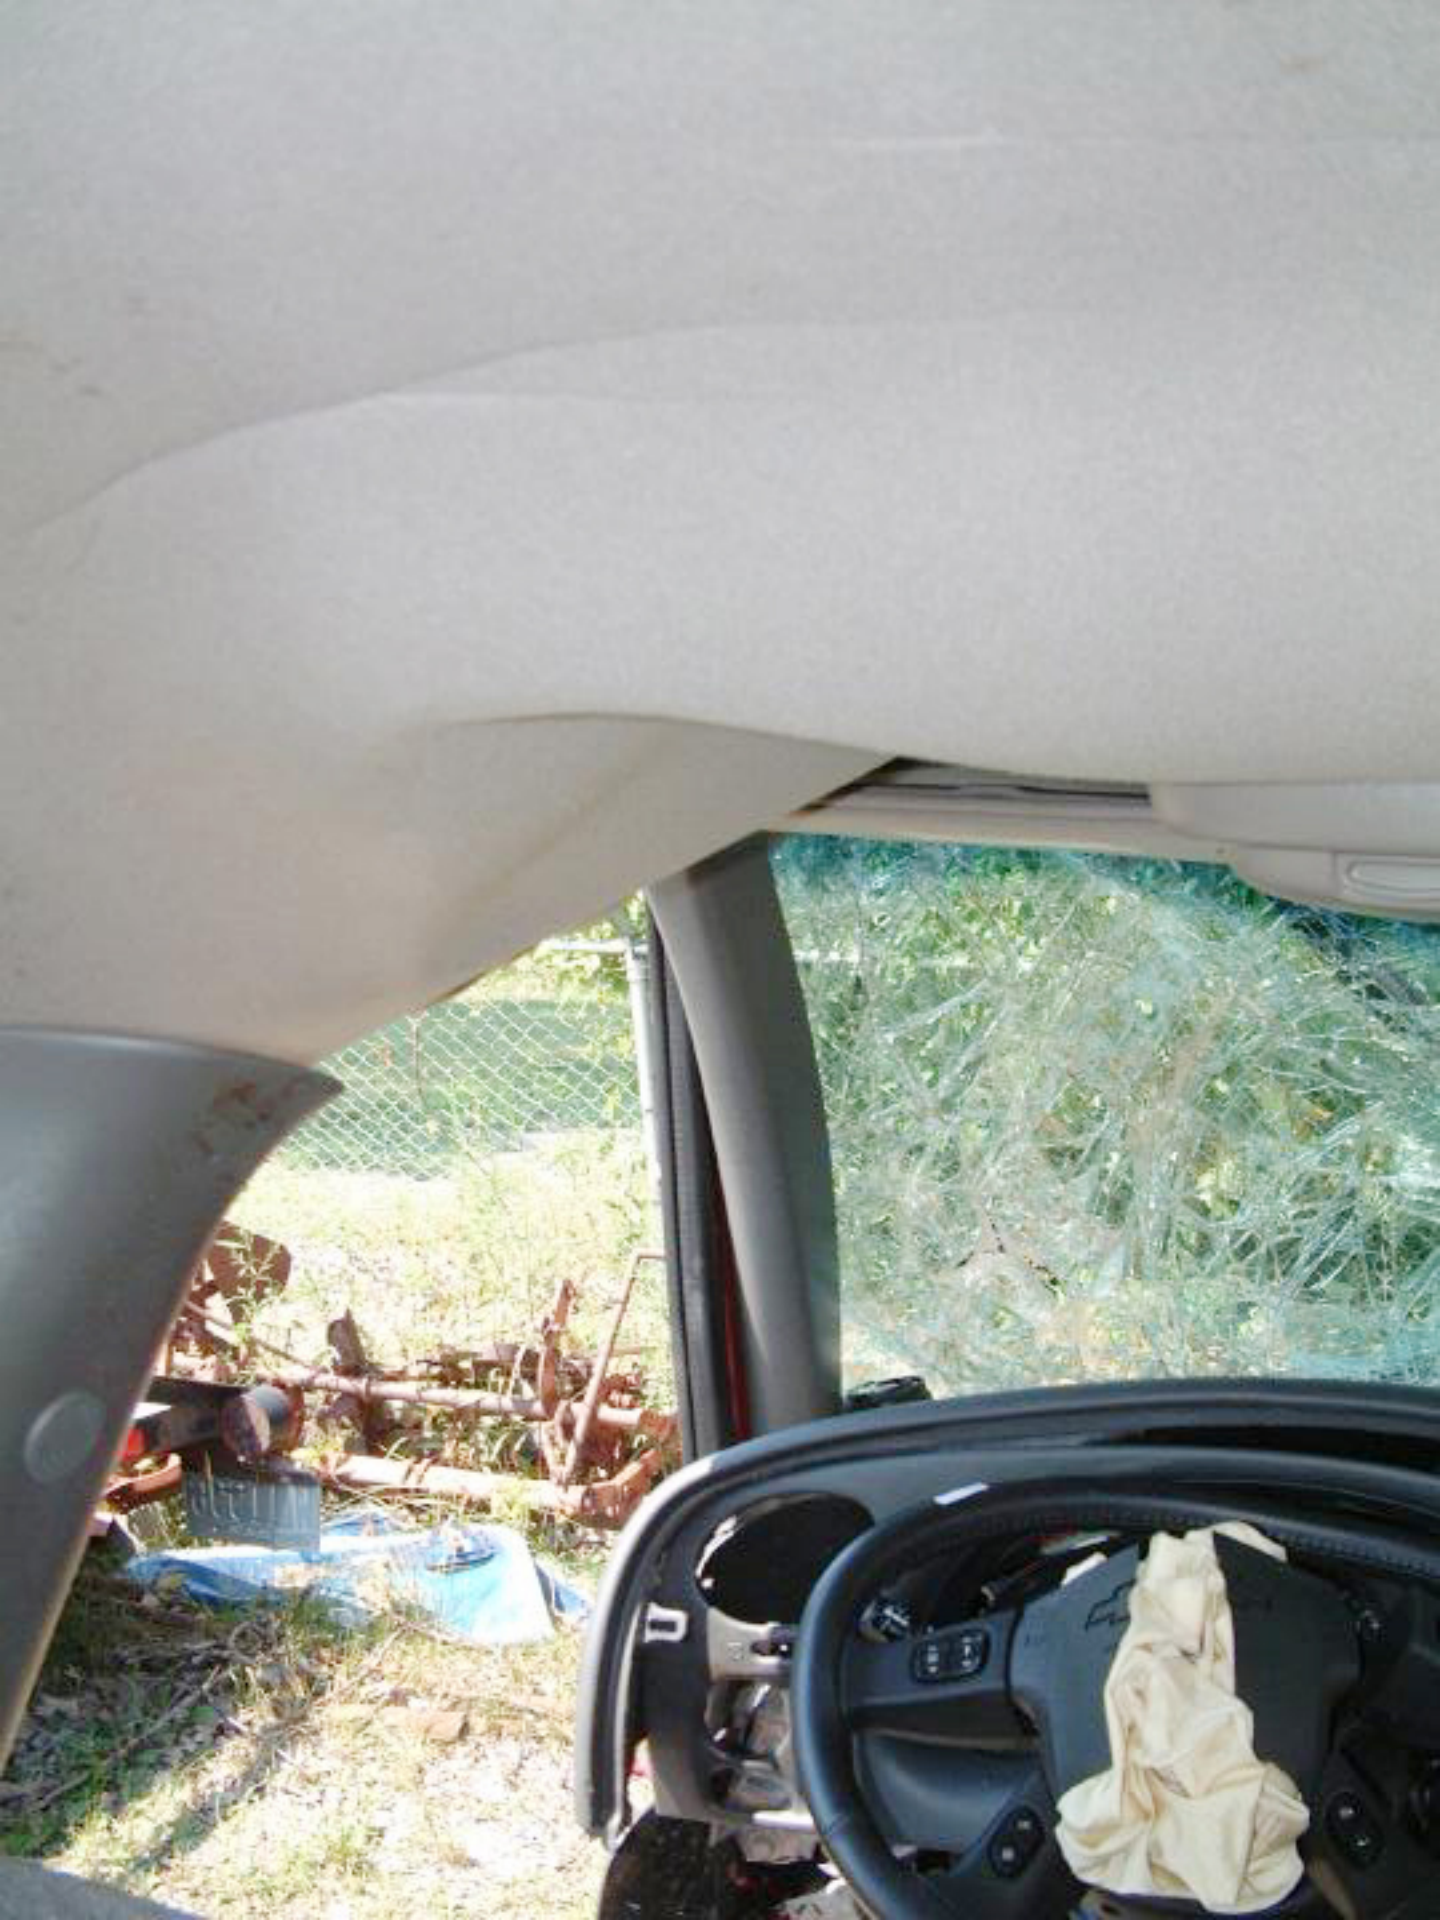
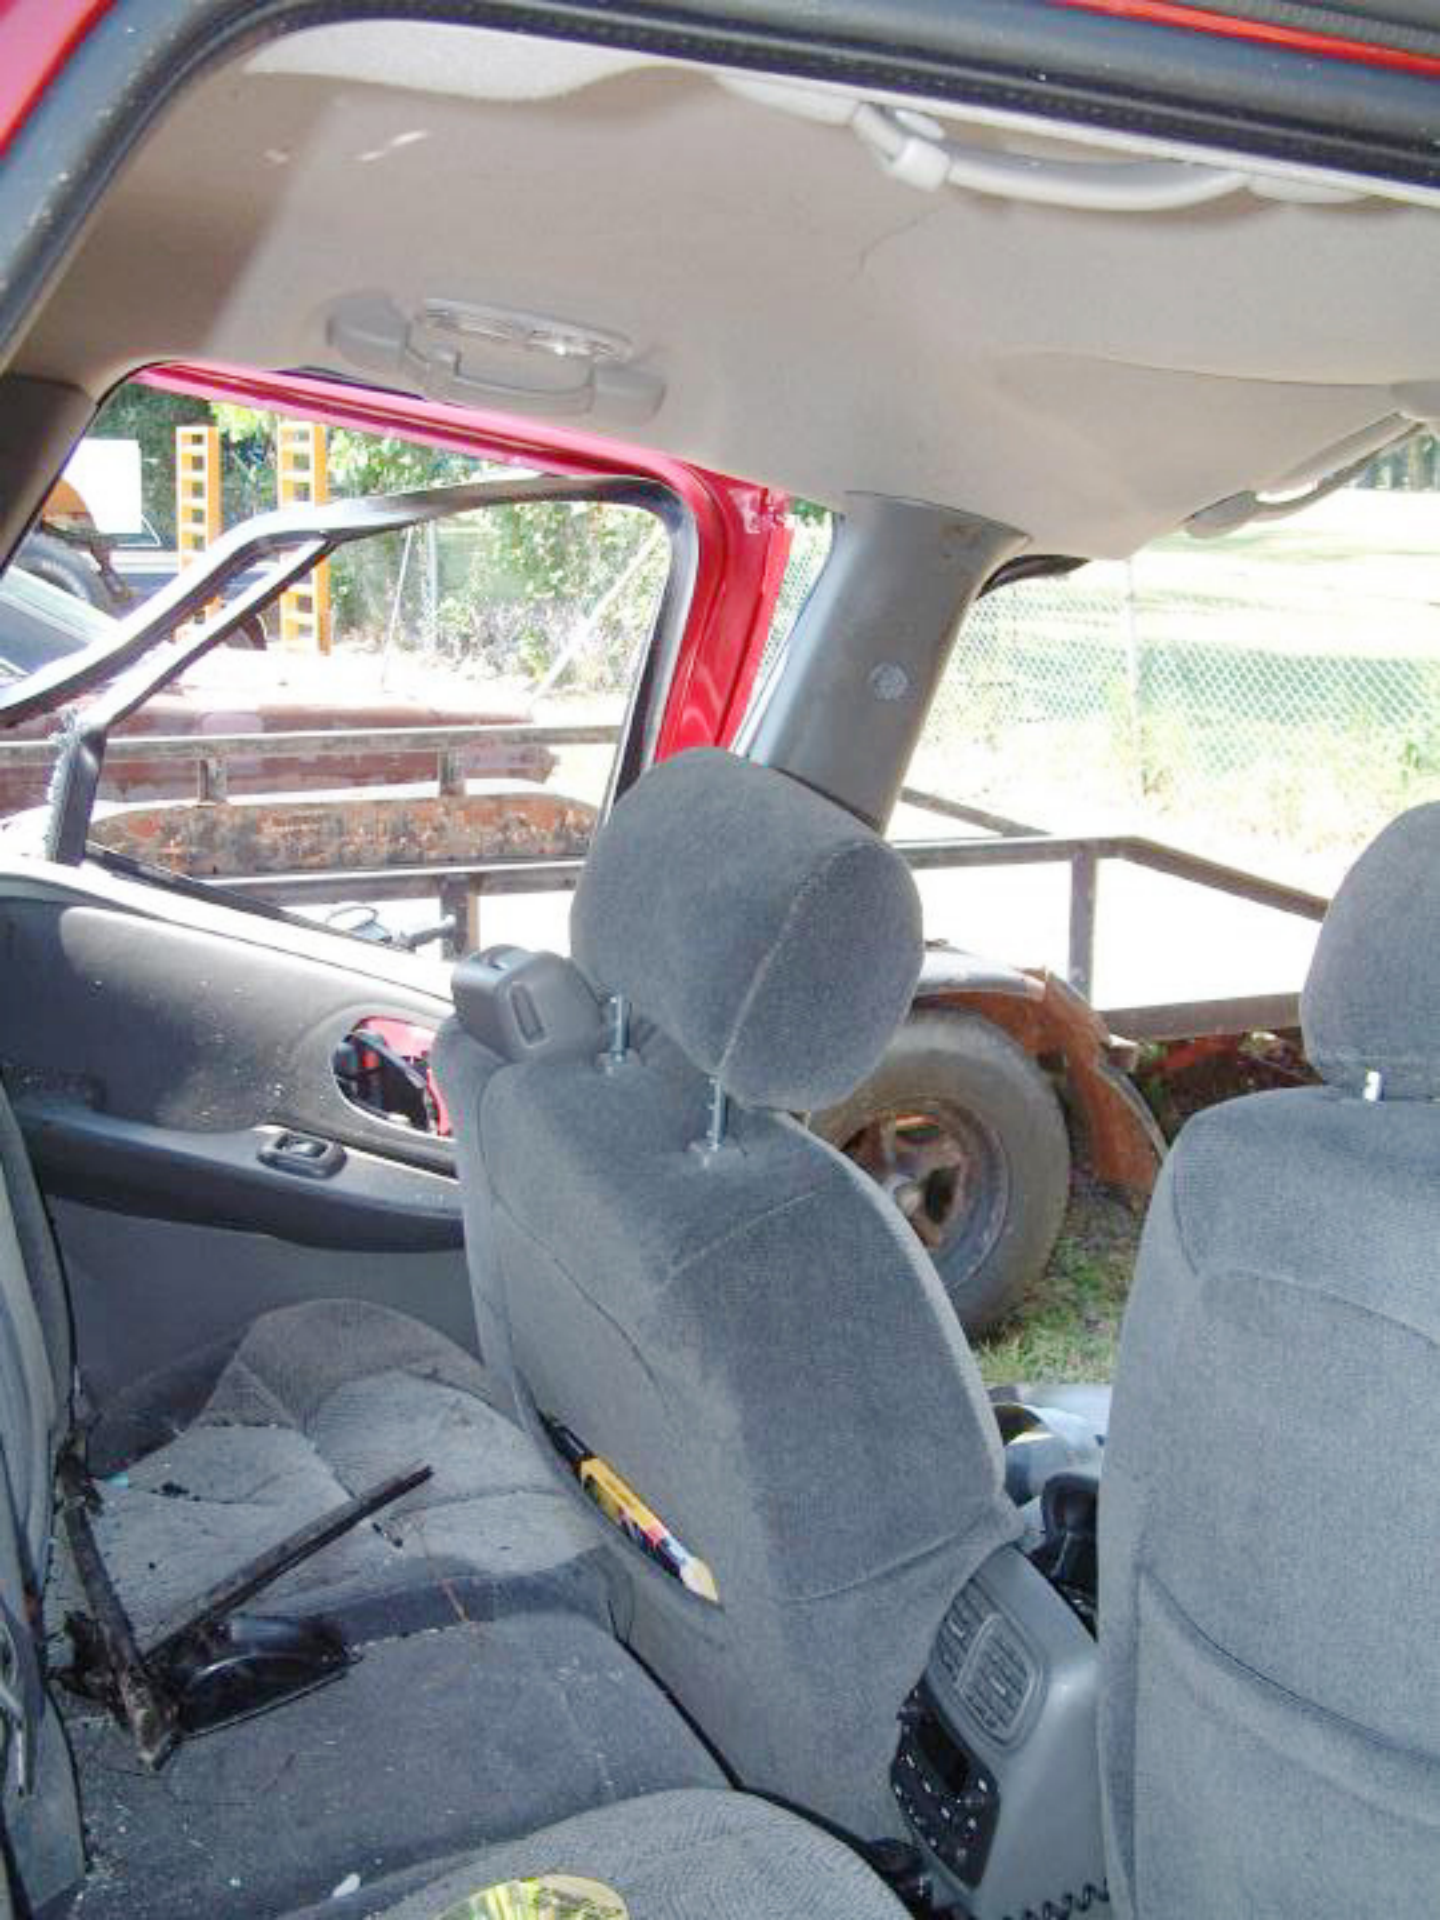
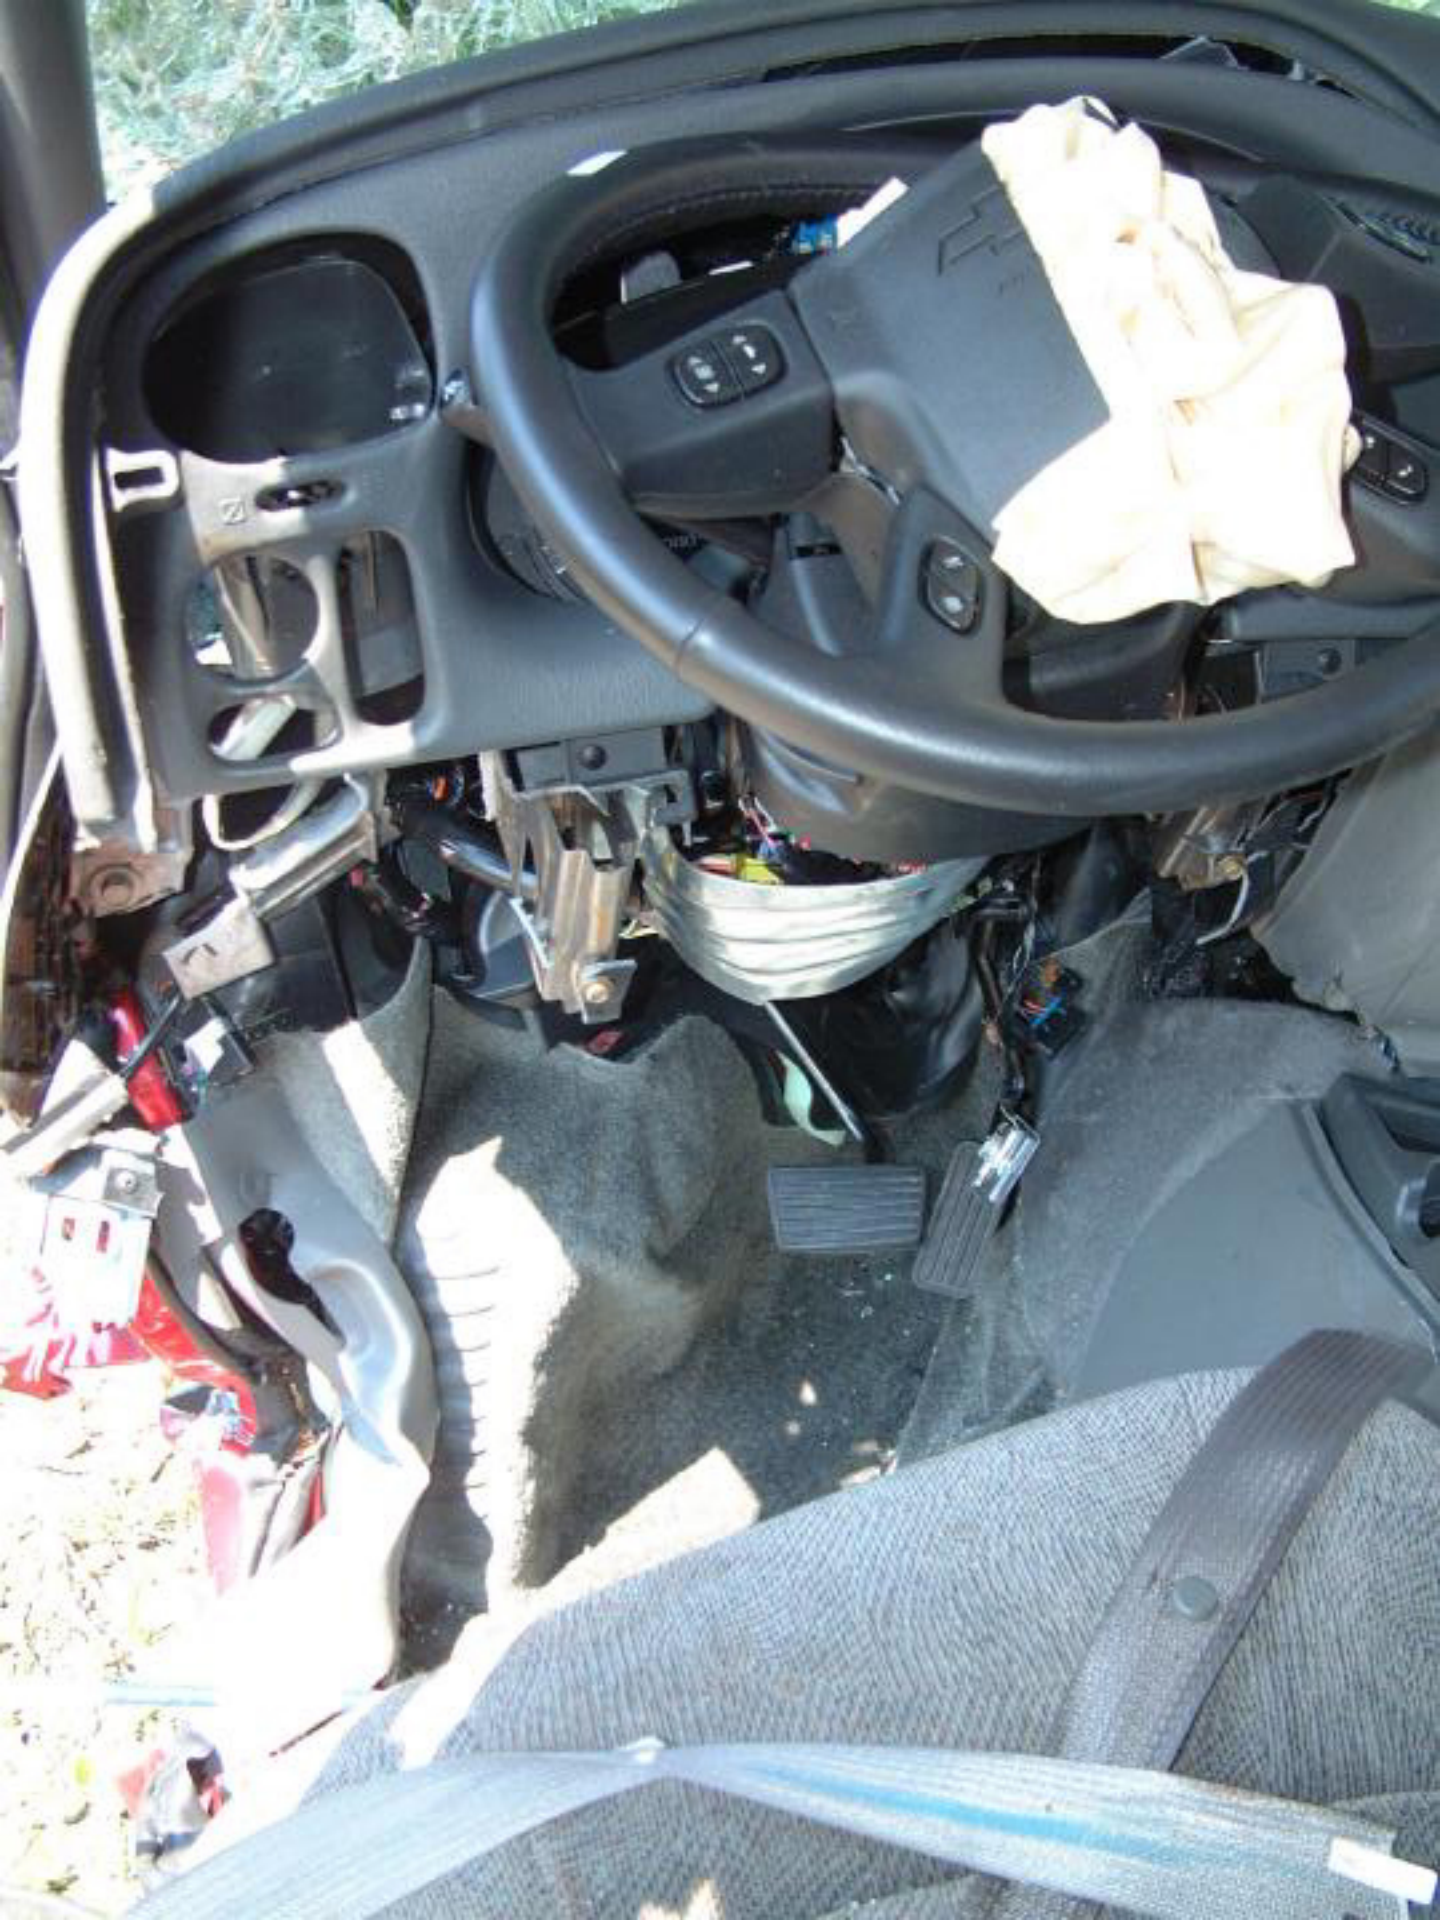
[75](#) [76](#) [77](#) [78](#) The 5-ft, 10-in, 300-lb, 54-year-old, male driver was using the seat-integrated three-point belt and the steering-wheel airbag deployed. Due to his large size, he was also using an after-market seatbelt extender. [79](#) [80](#) [81](#) Evidence of belt use includes a 20-cm blue material transfer on the shoulder-belt webbing from the driver's blue shirt, as noted in the autopsy report, webbing load marks on the continuous loop with wedging of the belt in the loop, [82](#) [83](#) cutting of the belt webbing during extrication of the driver, and the buckle tongue being inserted in the receptacle at the time of the vehicle inspection.

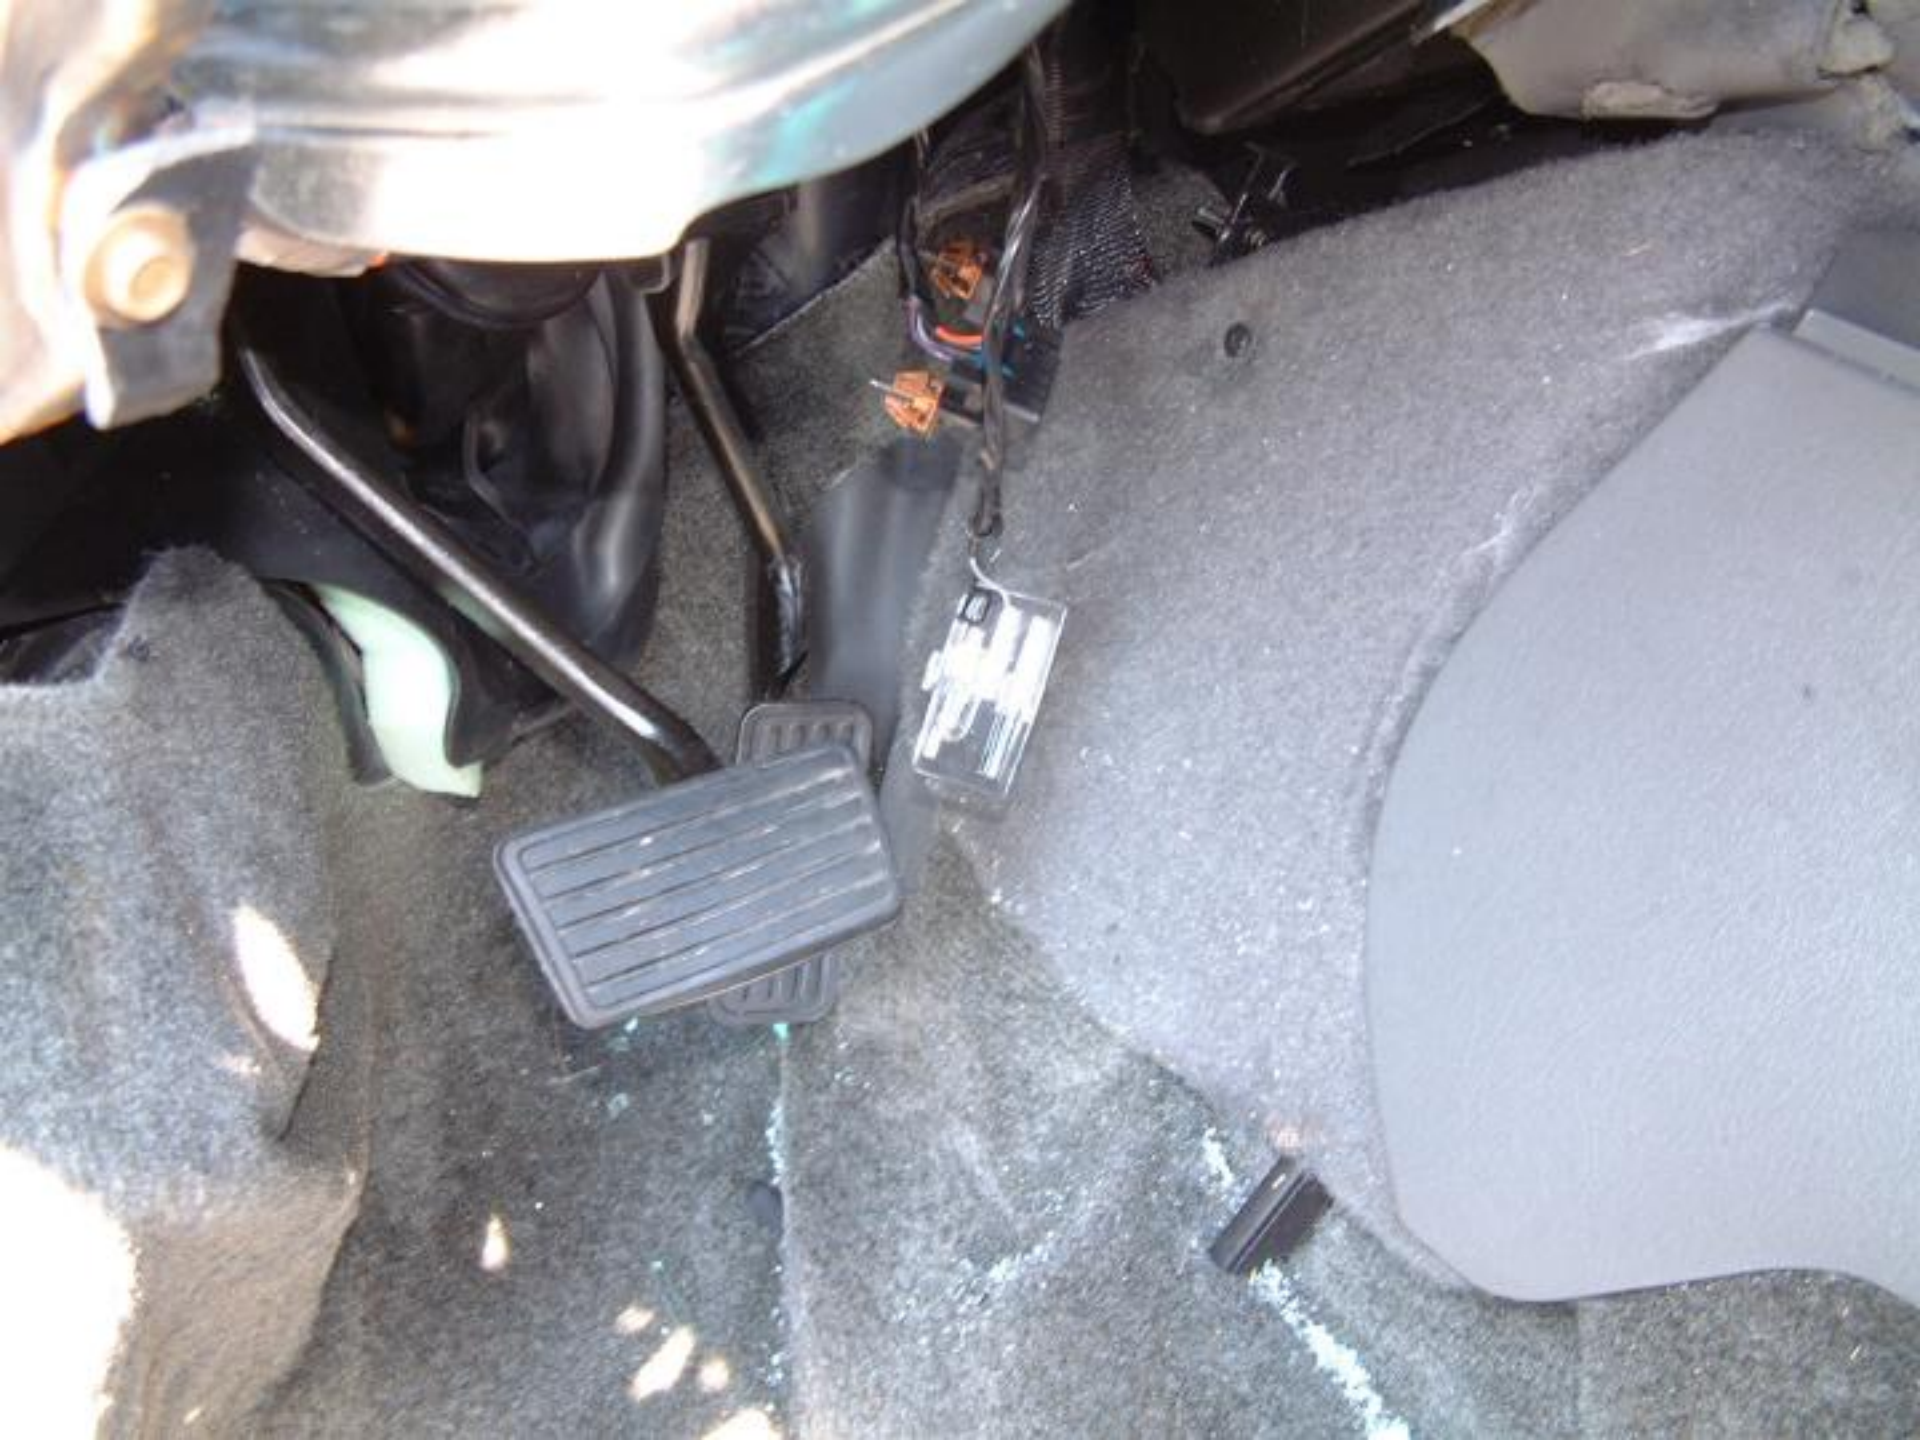
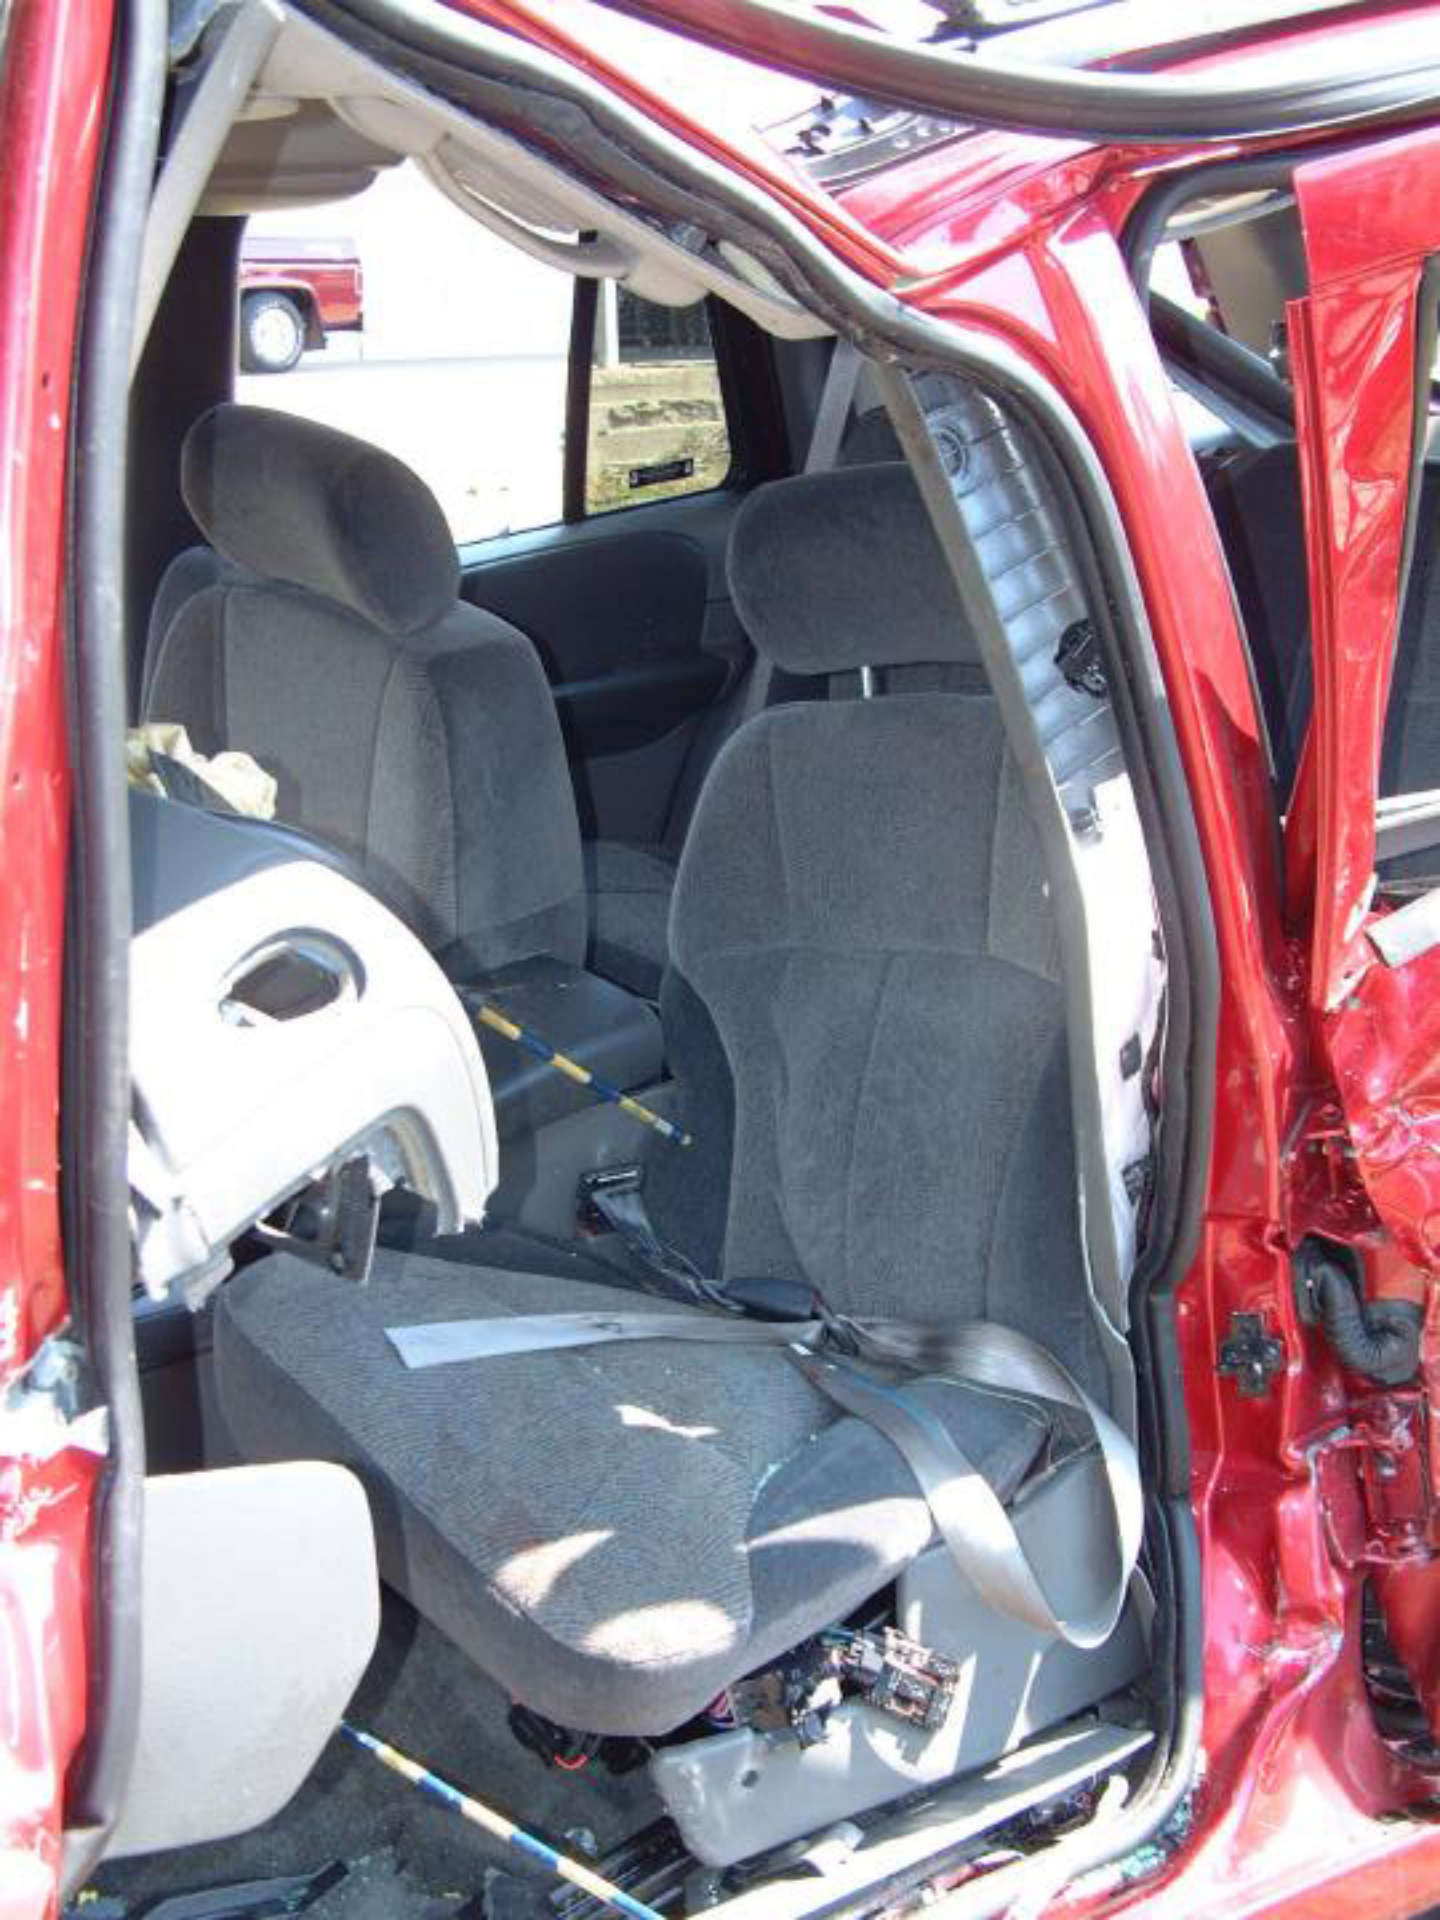
The driver sustained fractures to the distal portion of the left femur and to the right acetabulum [84](#) [85](#) from left and right knee contacts with the knee bolster, as evidenced by cloth transfers and scuff marks on the bolster to both sides of the steering column. He sustained abrasions over the left clavicle and a fracture to the left clavicle from loading by the shoulder belt, abrasions to the lower-left aspect of the neck, probably from loading by the shoulder belt but possibly from contact by the deploying airbag, and a horizontal abrasion from the right hip to the midline of the abdomen, probably from the loading by the lap portion of the belt. [86](#) [87](#) He sustained several thoracic and abdominal injuries, including

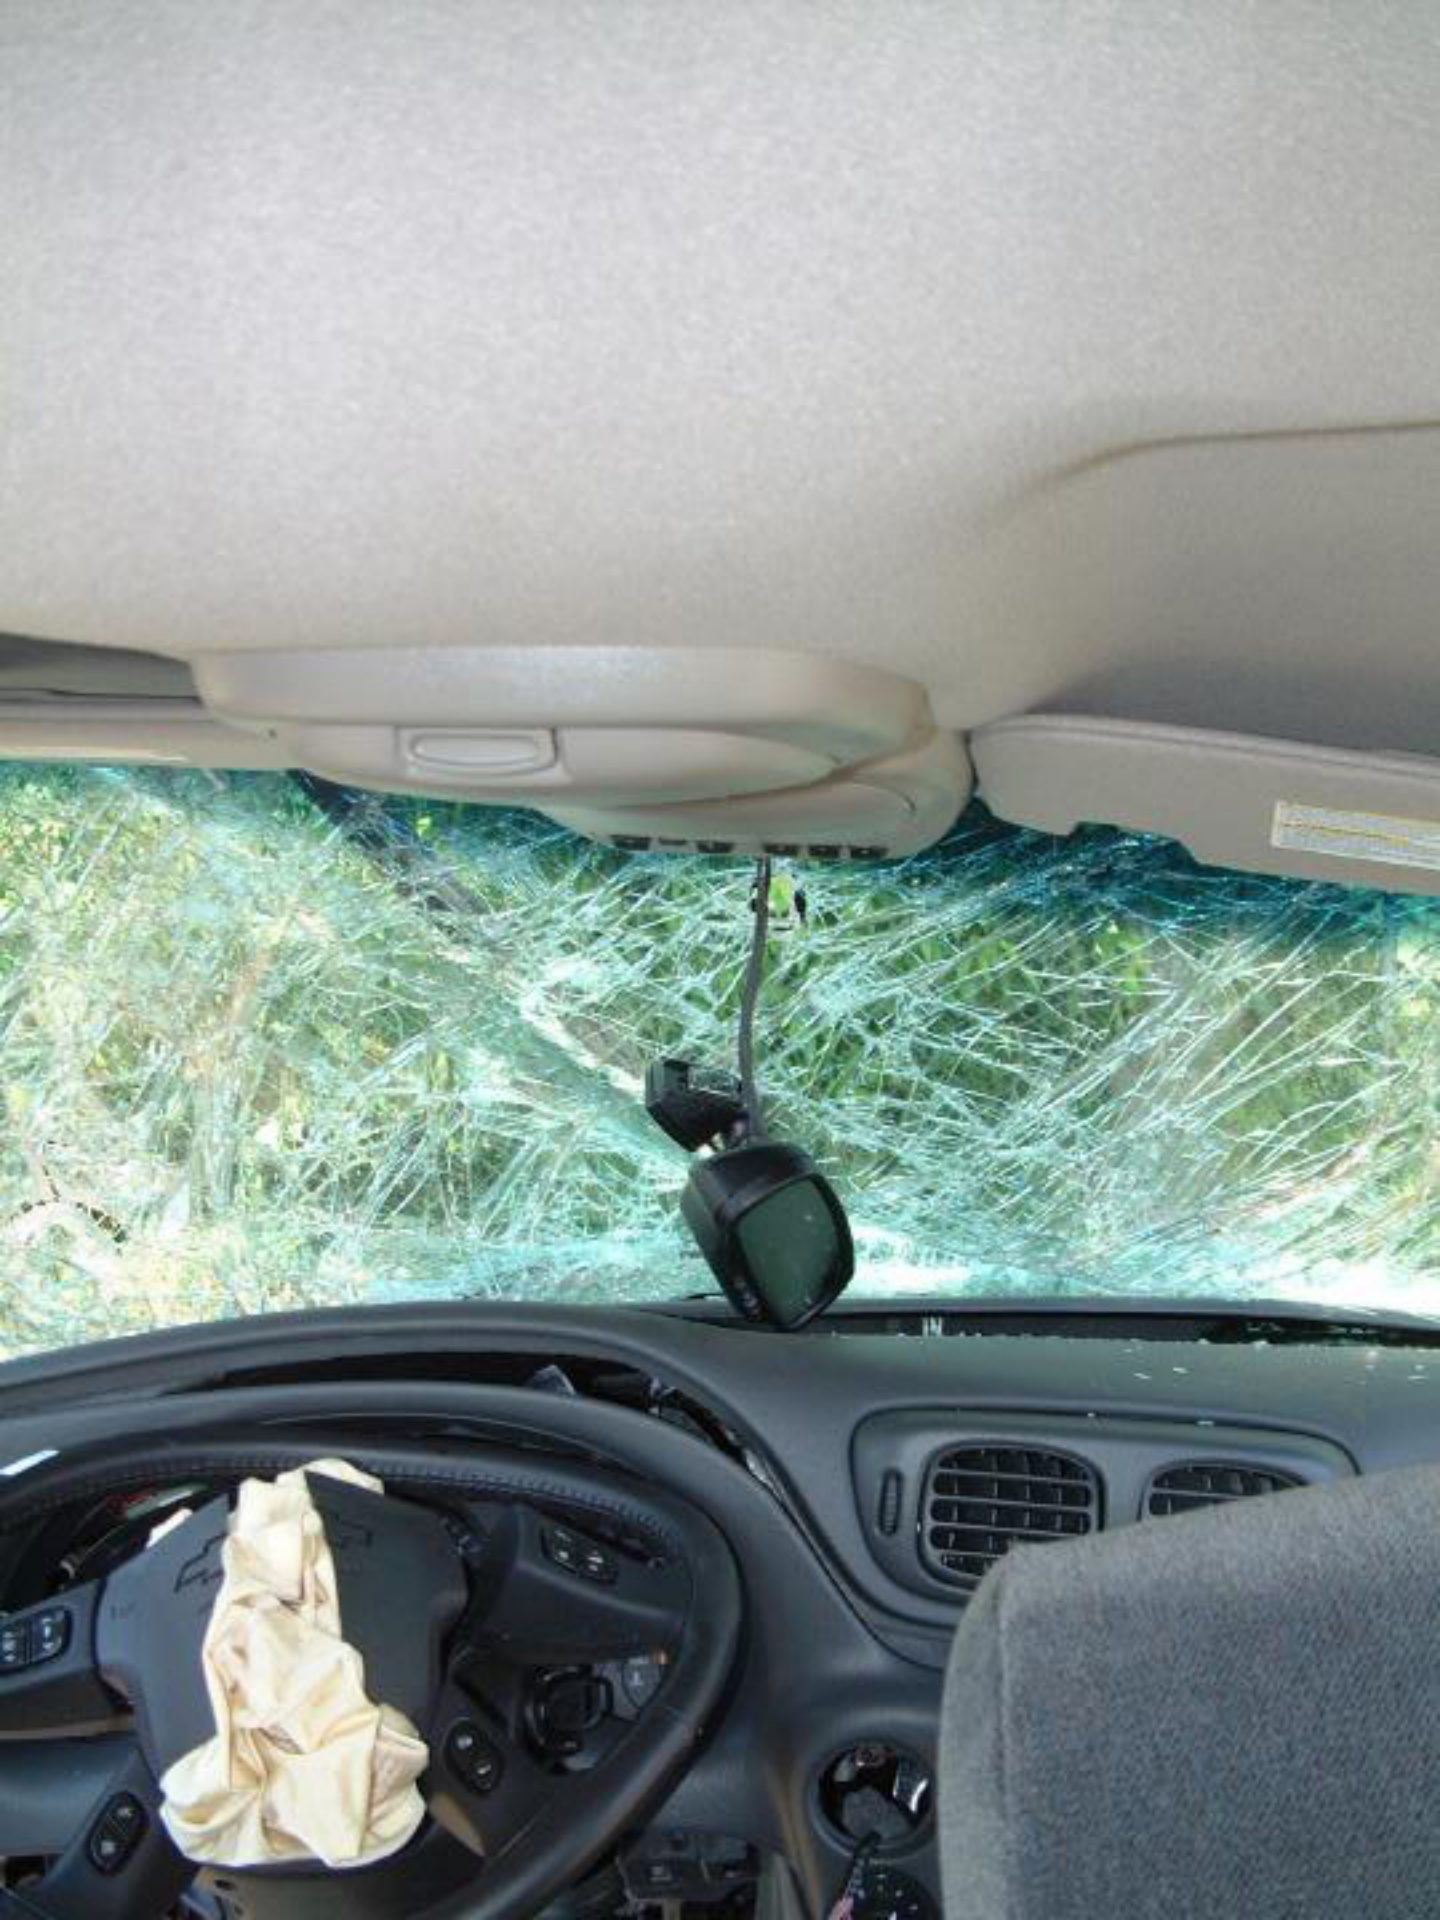
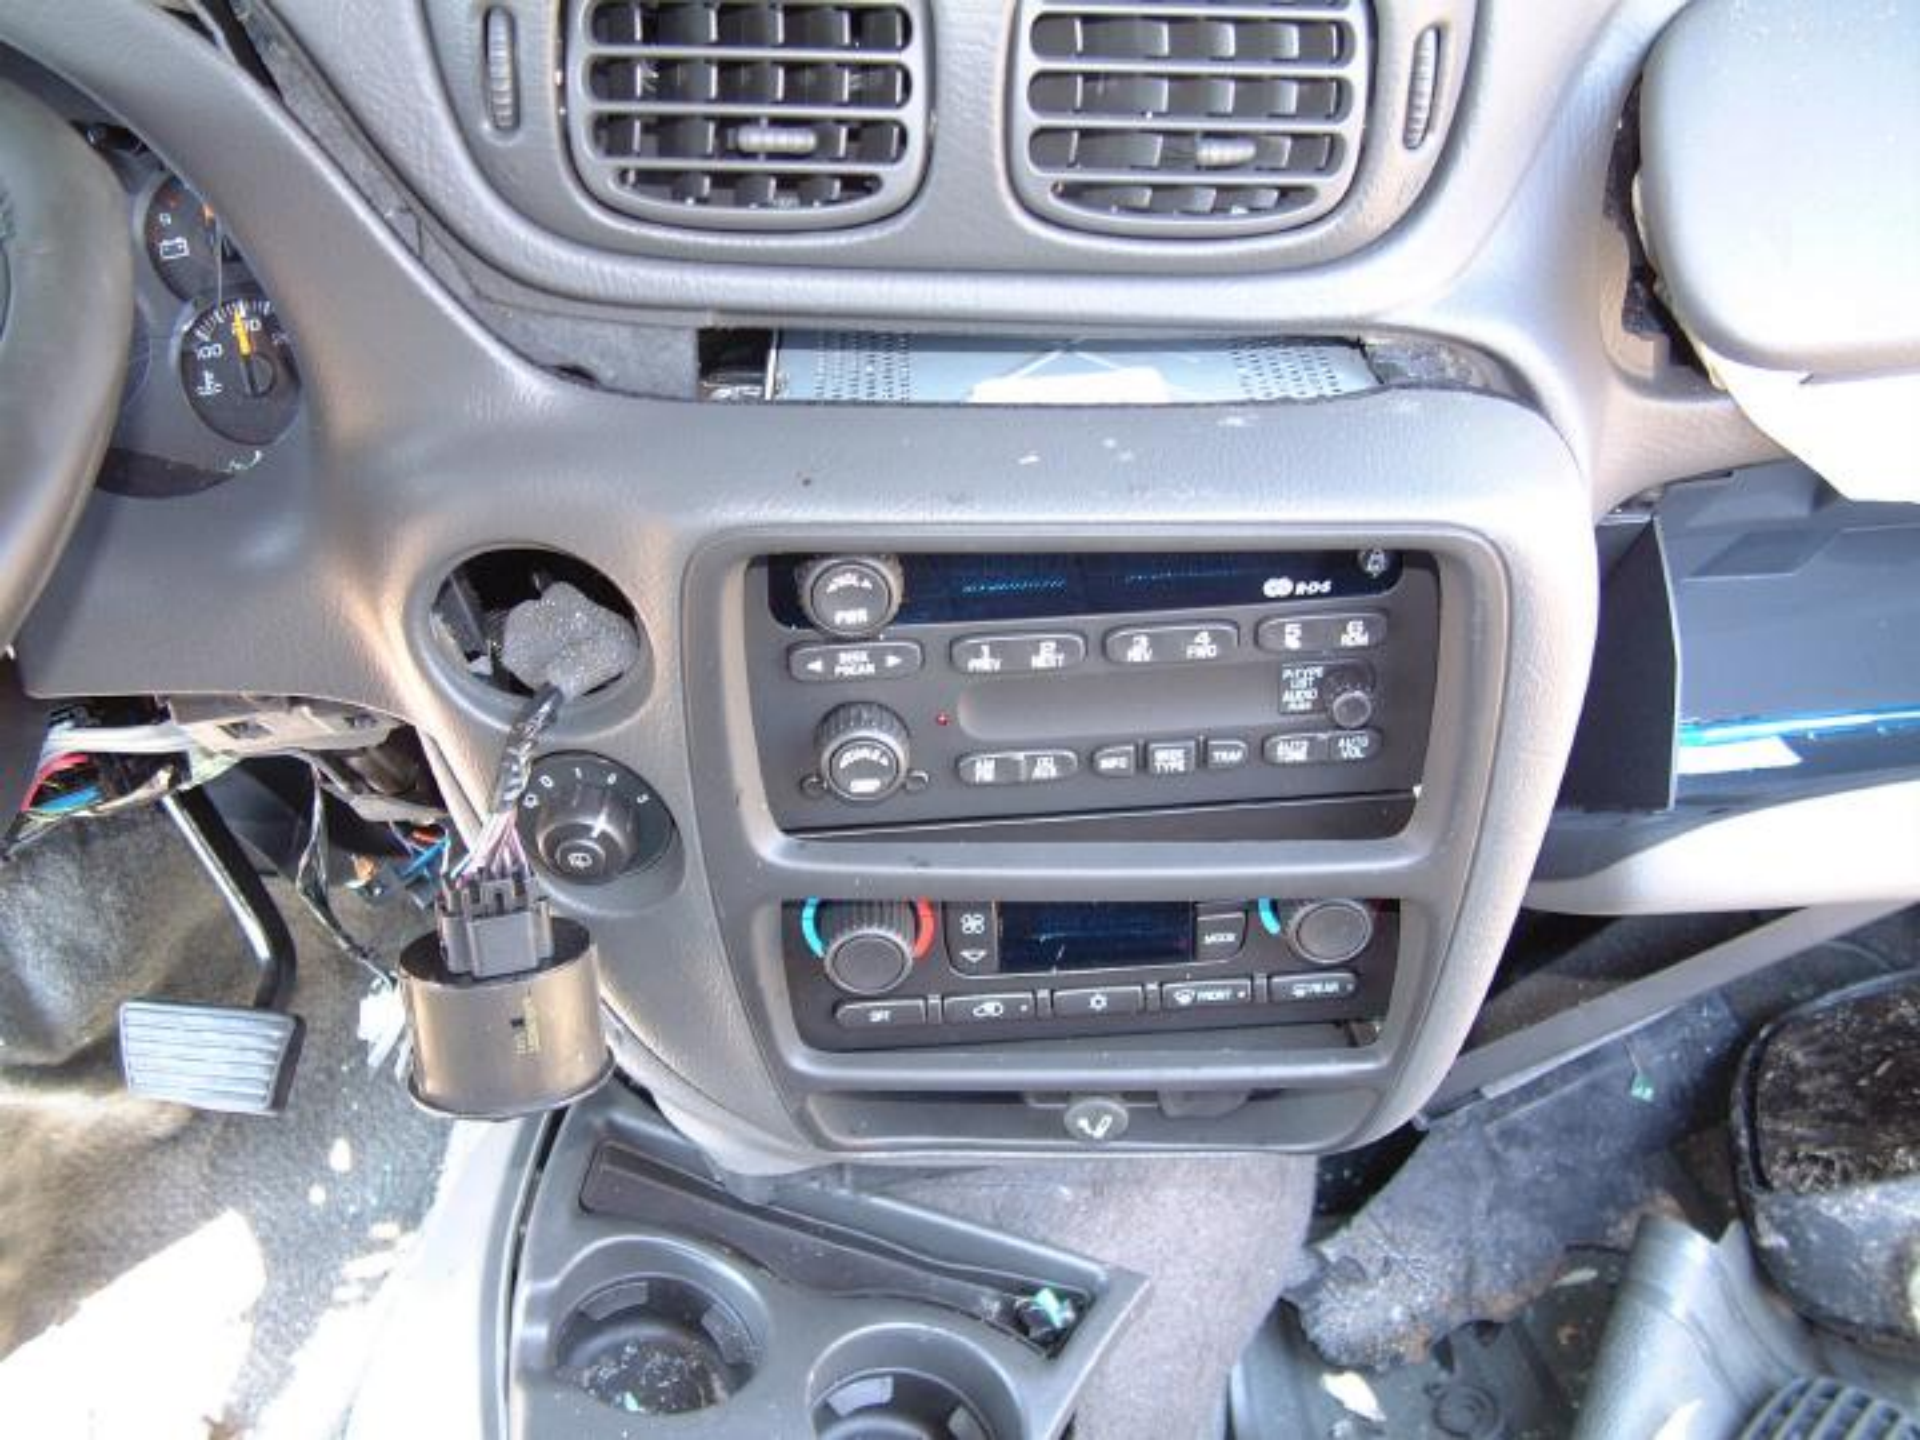
multiple displaced and non-displaced bilateral rib fractures with flail chest, a large full-thickness laceration to the right ventricle, bilateral lung contusions, a transected thoracic aorta with hemoperitoneum, lacerations to both the right and left sides of the diaphragm, multiple lacerations to the capsule and parenchyma of the liver, multiple lacerations of the spleen, and multiple chest and abdomen abrasions and contusions. These injuries probably resulted from a combination of shoulder belt and steering-wheel loading through the airbag, but may also have been caused by close-proximity chest and abdomen loading by the deploying airbag.
